IT7117B1-A(STI3B)

# Service Manual

## Induction hob

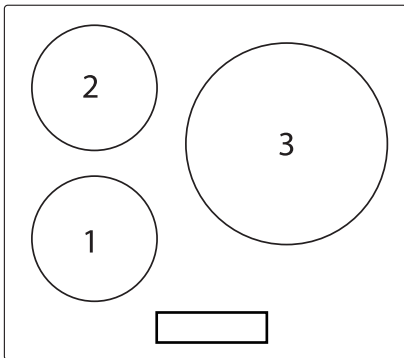
Heating zone	Size (mm)	Normal
1	∅ 180	1500 W
2	∅ 180	2000 W
3	∅ 290	3000/3600 w

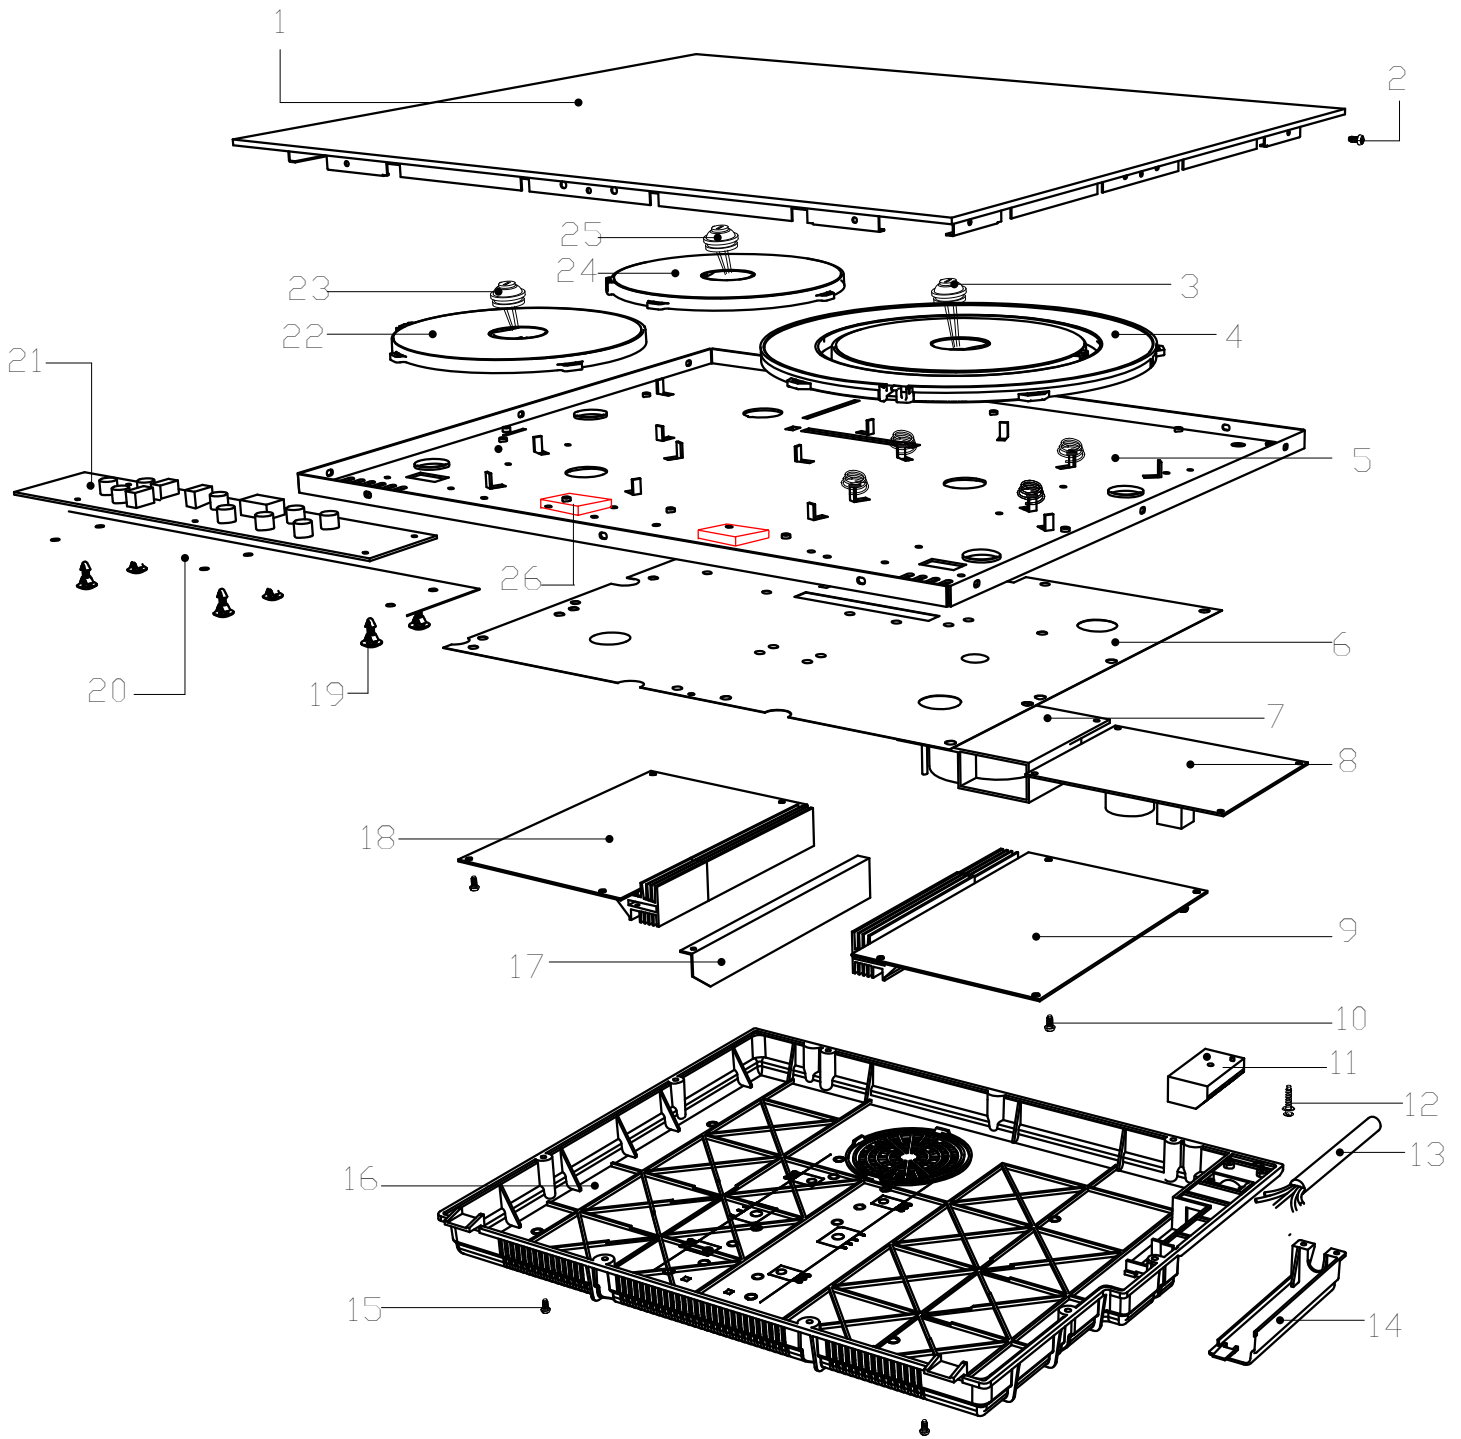
Exploded view

No.	CODE	Q'ty	COLOR	
40	303206800036	2	RED/450mm	
41	303206800041	2	RED/150mm	
42	303206800159	2	RED	
43	303206800157	2	BLUE	
44	303206800158	1	YELLOW/GREEN

<b>MC-IT7117B1-A(STI3B)</b>				
<b>No.</b>	<b>Parts code</b>	<b>Parts names</b>	<b>QTY</b>	<b>Series No.</b>
1	542000606291+ 542300000060	glass assembly	1	
2	301500101374	Screw	12	
3	541600200011	the ceramic plate temperature sensor	1	
4	542300300001	542200000012 290 Coil groupware	1	
		542300300005 180 Coil groupware	1	
5	541400300011	radiator board	1	
6	541700500006	isinglass flake B	1	
7	541600100004	Fan	1	
8	541500200005	accessorial power	1	
9	541500000030	Power board	1	
10	301500101197	Screw	6	
11	541810000002	junction port holder	1	
12	301500101200	Screw+gasket	1	
13	541800000017	Power Cord	1	
14	541300600011	power cord case cover	1	
15	301500100954	Screw	10	
16	541300100005	Base	1	
17	303207300215	windshield insulating flake	1	
18	303203101364	Power board	1	
19	303207300211	knighthead	3	
20	541700300019	isinglass flake A	1	
21	303203101395	Display board	1	
22	542200000013	160 Coil groupware	1	
23	541600200011	the ceramic plate temperature sensor	1

24	542200000009	180 Coil groupware	1	
25	541600200010	the ceramic plate temperature sensor	1	
26	541700700002	Supporting Foam	2

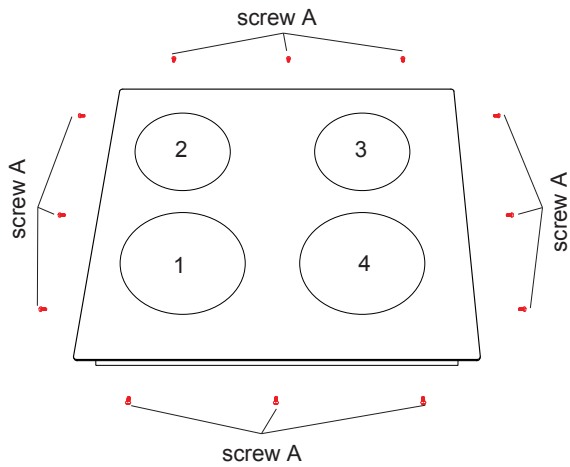
Step1:  
remove the screw A around the base cover

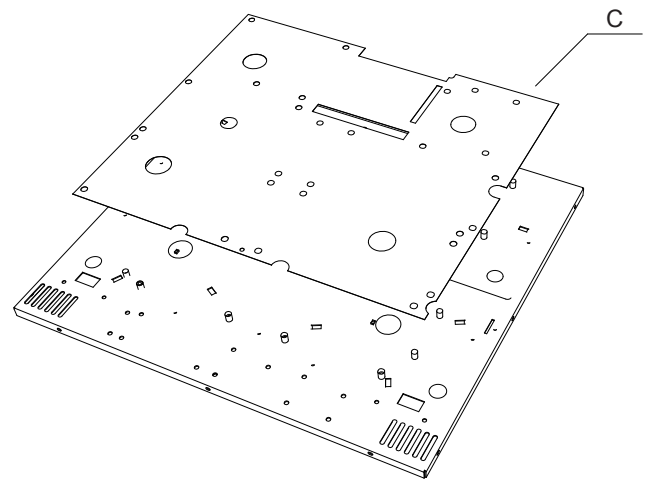
Step 4:  
Remove C

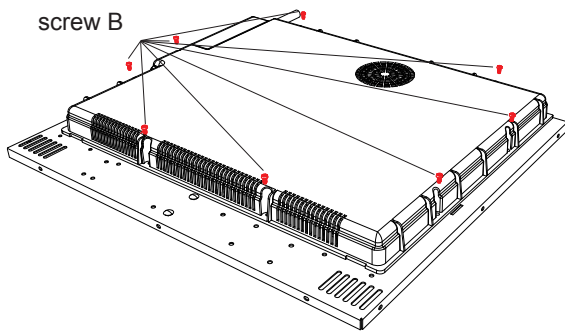
Step2:  
remove the screw B

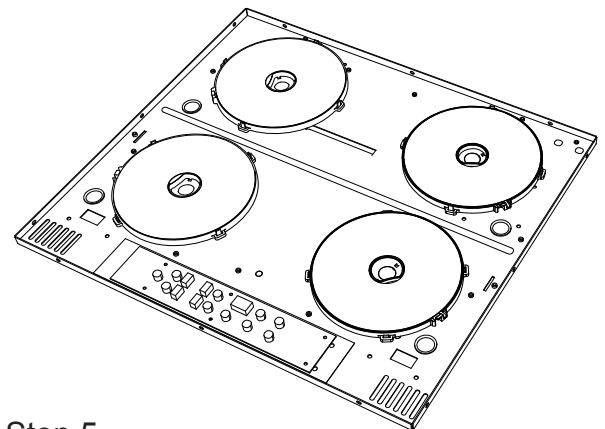
Step 5:  
reserve the product

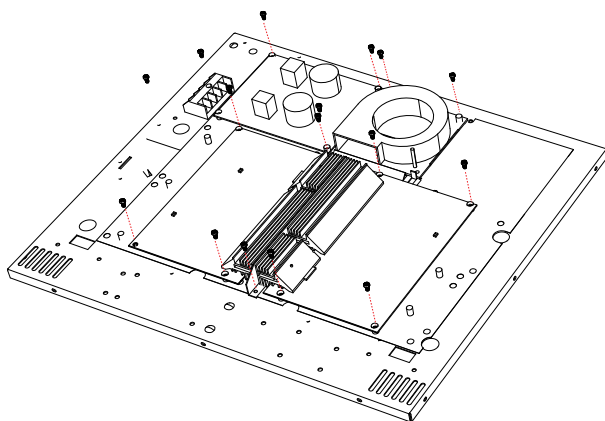
Step 3:  
remove all the screws and wires

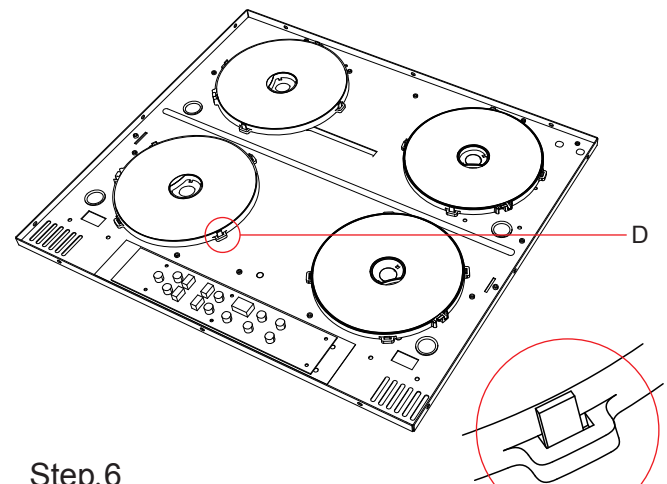
Step.6  
to remove the induction coil, straighten  
the buckle of D

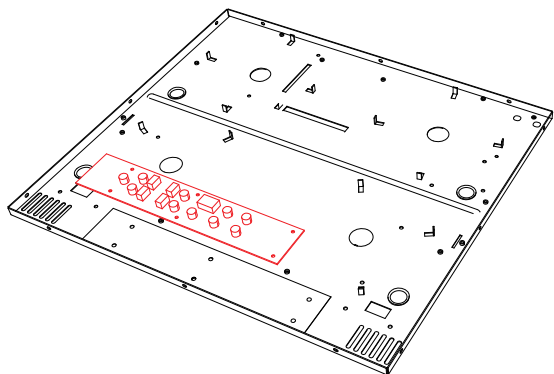
Step 7:  
remove the display board

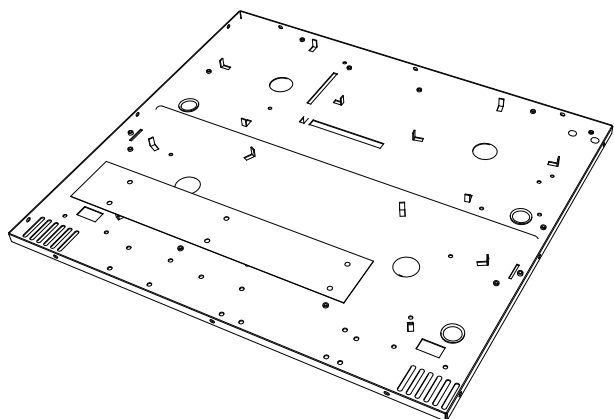
Step 8:  
done
